Re : Non-destructive examination of Touchtone 12 -
PWB and component mounting

Examination of PWB for Touchtone 12 reveals the following shortcomings:

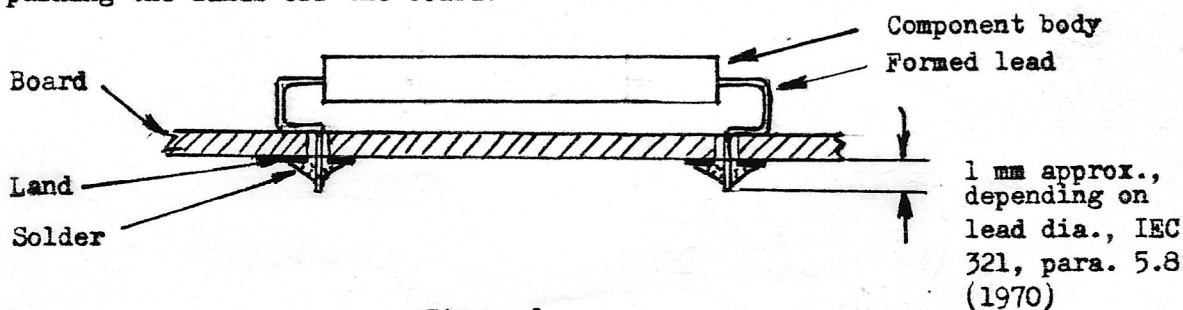
Figure 1

- 2.2 On the solder side of the board, the component leads and connecting wires protrude too far above the surface (Photo No. 5, Items 1, 2, 3 and Fig. 1).
- 2.3 Glass encapsulated diode should have at least one of the leads formed into a loop (See Fig. 2) to prevent breaking of the seals between the glass and the leads during thermal expansion and contraction. None of the glass encapsulated diodes have their leads properly formed. (Photo No. 9, Item 1).
