The Telecommunication Journal of Australia

VOL. 11, No. 3

FEBRUARY, 1958

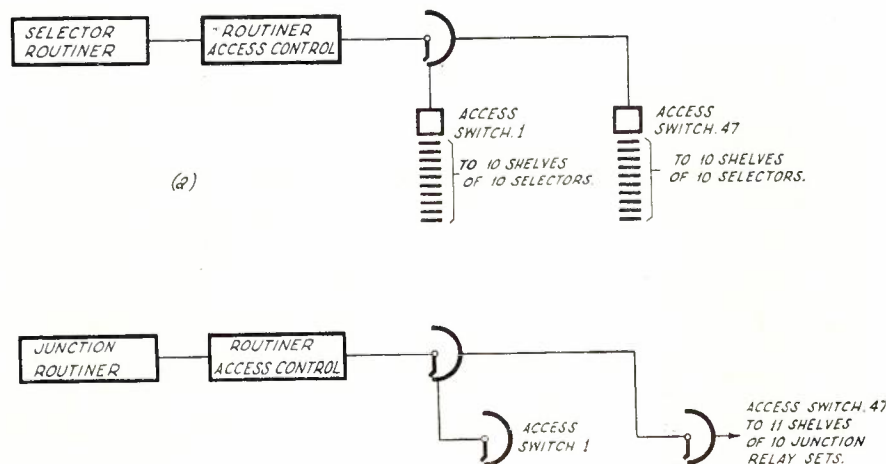
(b) Fig. 1.—Typical Routiner Access Arrangement.

ber of operated lamps on the routiner lamp display panel will identify the faulty switch and the particular fault condition by giving rack, shelf, switch and fault numbers. Manual attention is then required to record these lamp numbers and to resume the testing on the next switch. A typical routiner access arrangement is shown in Fig. 1 and a photograph of a selector routiner lamp panel is shown in Fig. 2.

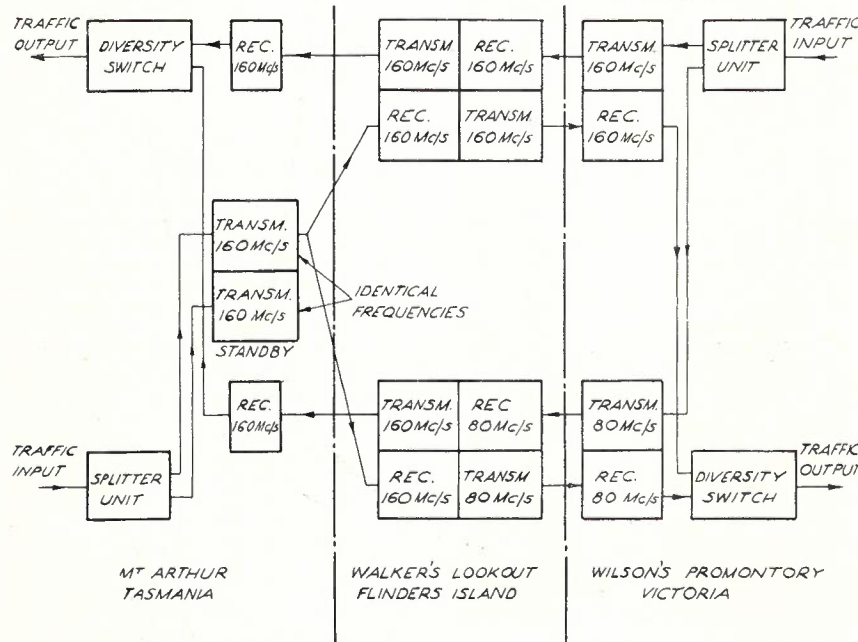
Fig. 7.—Frequency Diversity Scheme—Block Schematic.

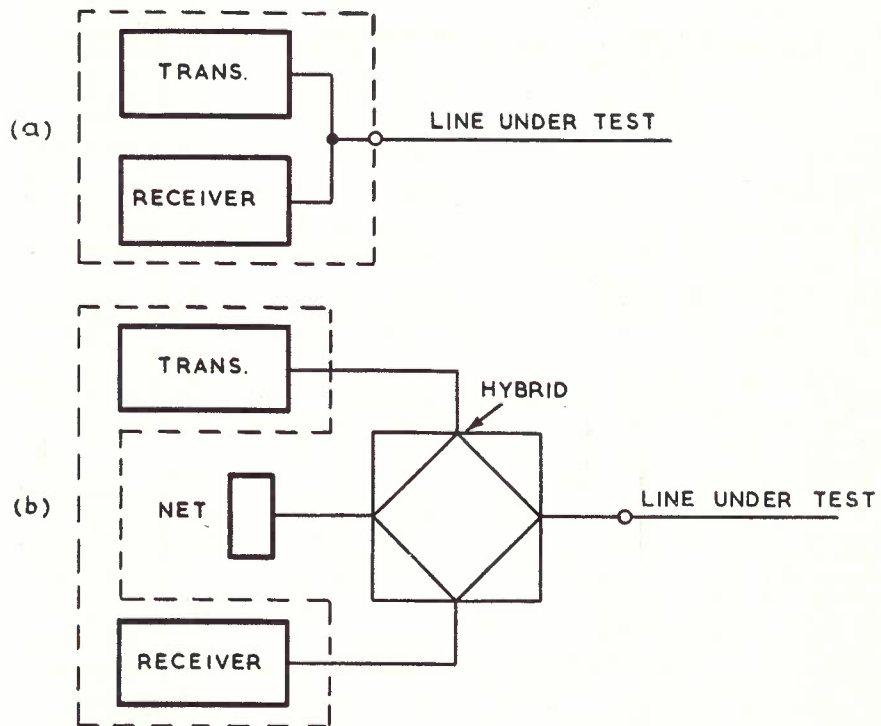
Fig. 4.—2-Wire and 4-Wire Connection of Transmitter and Receiver (FLOS apparatus shown inside dotted line).

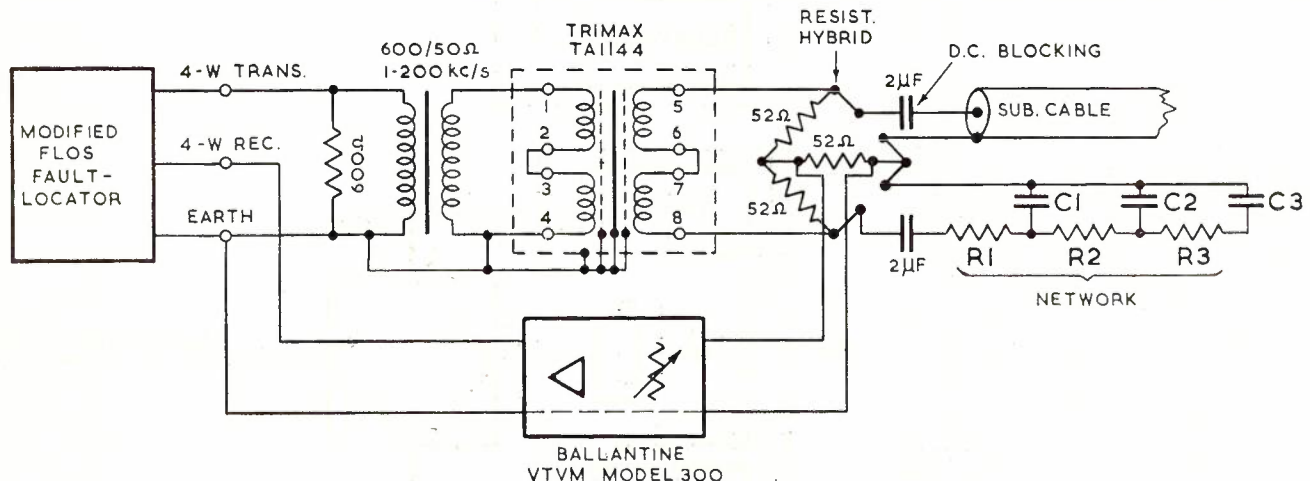
Fig. 5.—Pulse Echo Testing Apparatus for Fault Location on Bass Strait Submarine Telephone Cables.

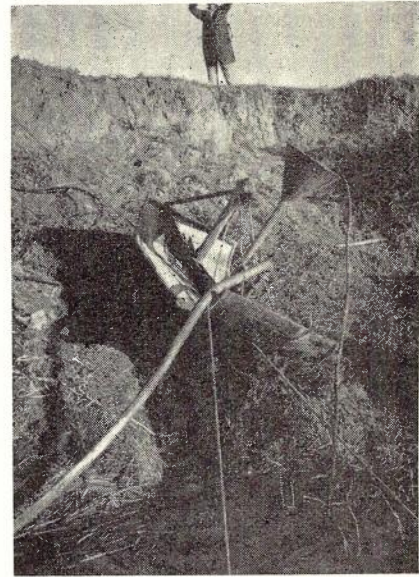
Fig. 4.—Skid Plough Entering River.

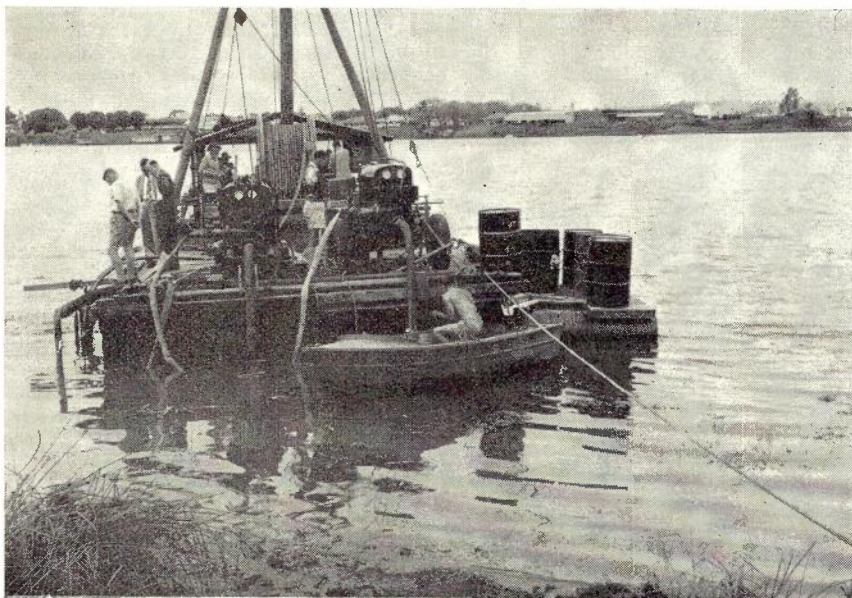
Fig. 8.—Preparing to lay Cable at Grafton.

Fig. 8 shows the pumps and drum of cable in position on the barge. The weight to take the water jets to the bottom can be seen on the left hand side of the barge. The rope along which the barge is propelled is on the right hand side. Due to the size, weight

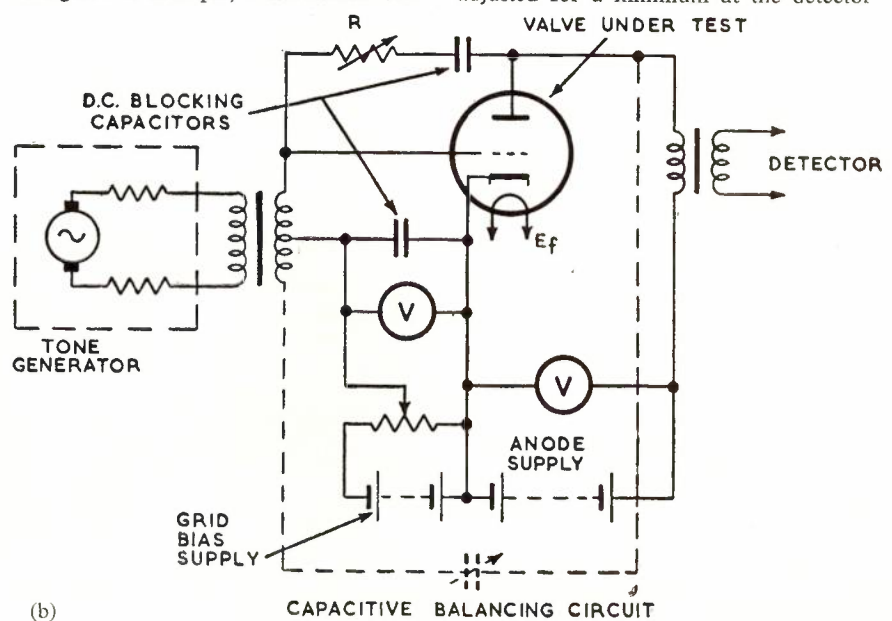
Q.1.—Fig. 2.

One circuit using this method is shown in Fig. 2. The tone generator supplies a small alternating voltage to the grid of the valve under test and also to a variable resistor R which may conveniently be a decade resistance box. When R is adjusted for a minimum at the detector
